PRIMARY RECORD

* Resource Name or #: 15411 Cascade Lane

* P11. Report Citation: (Cite survey report/other sources or "none") San Diego Freeway (I-405) Improvement Project
Historical Resources Evaluation Report California Project Historical Resources Evaluation Report

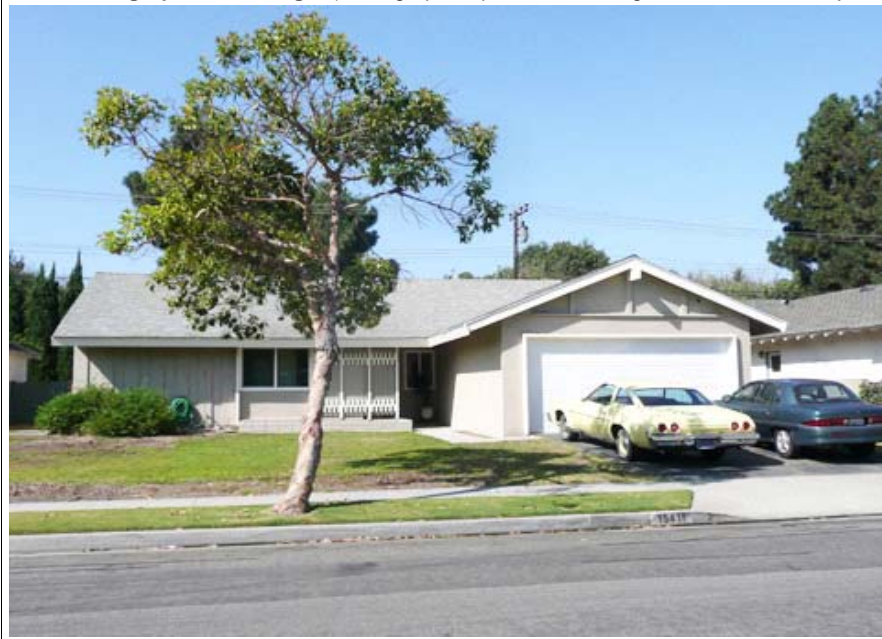
Facing southwest; 9/1/2010; Photo No.
P1040743.jpg

* P3a. Description: (Describe resource and its major elements. Include design, materials, condition, alterations, size, setting, and boundaries.)
The one-story Ranch style building is 'L'-shaped in plan. The cross gabled roof, with boxed eaves, is clad in composition shingles. The front-facing gable is accented with false timbering and a false beam at the apex of the gable. The exterior walls are clad in smooth textured stucco, and the southern end of the primary façade (east) is clad in vertical board and batten wood siding. The windows have been replaced with vinyl sliding units. The primary entrance is recessed and is accented by a decorative wood screen and low concrete block wall. The building does not meet the NRHP and CRHR eligibility criteria for the reasons identified on the district record prepared for this subdivision; therefore the building does not contribute to a historic district and is not individually eligible for listing in the NRHP and the CRHR.

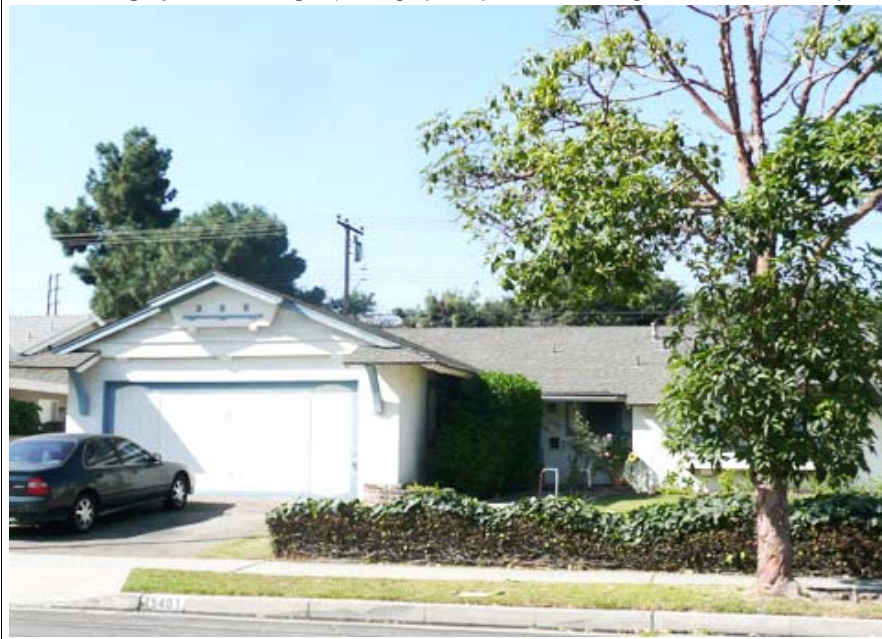
Facing southwest; 9/1/2010; Photo No.

* P3a. Description: (Describe resource and its major elements. Include design, materials, condition, alterations, size, setting, and boundaries.)
The one-story Ranch style building is 'L'-shaped in plan. The cross gabled roof, with boxed eaves and cornice returns supported by brackets on the front facing gable, is clad in composition shingles. The front-facing gable is further accented with a dovetail, horizontal wood siding, and corbels. The exterior walls are clad in smooth textured stucco. The diamond-pane sash windows appear to be original, and are accented with shutters. The north end of the primary (eastern) façade is further with a projecting bay with corbels. The primary entrance is recessed, accessed via a cast concrete porch, and is accented with vertical wood siding. The roof overhangs to shelter the primary entry porch and is supported by a turned wood post. An attached two-car garage projects from the southern end of the primary (east) façade, and is characterized by a wood pivot door, which appears to be original. The building does not meet the NRHP and CRHR eligibility criteria for the reasons identified on the district record prepared for this subdivision; therefore the building does not contribute to a historic district and is not individually eligible for listing in the NRHP and the CRHR.

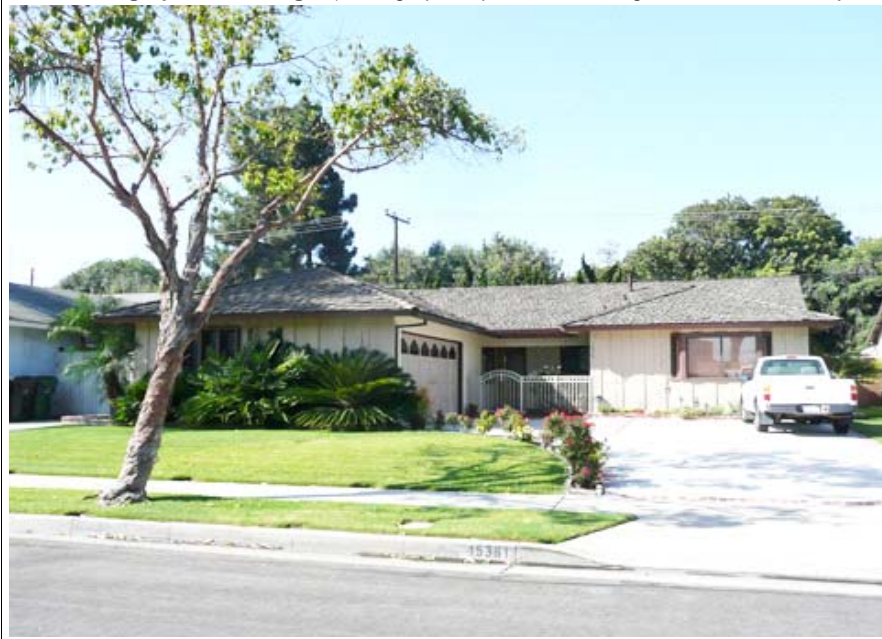
Facing west; 9/1/2010; Photo No.

* P3a. Description: (Describe resource and its major elements. Include design, materials, condition, alterations, size, setting, and boundaries.)
The one-story Ranch style building is 'L'-shaped in plan. The cross side gable and hipped roof, with boxed eaves, is clad in wood shingles. The exterior walls are clad in smooth textured stucco and vertical board and batten siding. The windows have been replaced with modern anodized units. The primary entrance is recessed and a modern metal fence creates a private courtyard, which is accented with a small trellis cantilevered from the roof eave. An attached two-car garage projects from the southern end of the primary (eastern) façade. The east façade of the garage is accented with three fixed-pane windows with pebble glass accented with exaggerated wood surrounds. The building does not meet the NRHP and CRHR eligibility criteria for the reasons identified on the district record prepared for this subdivision; therefore the building does not contribute to a historic district and is not individually eligible for listing in the NRHP and the CRHR.

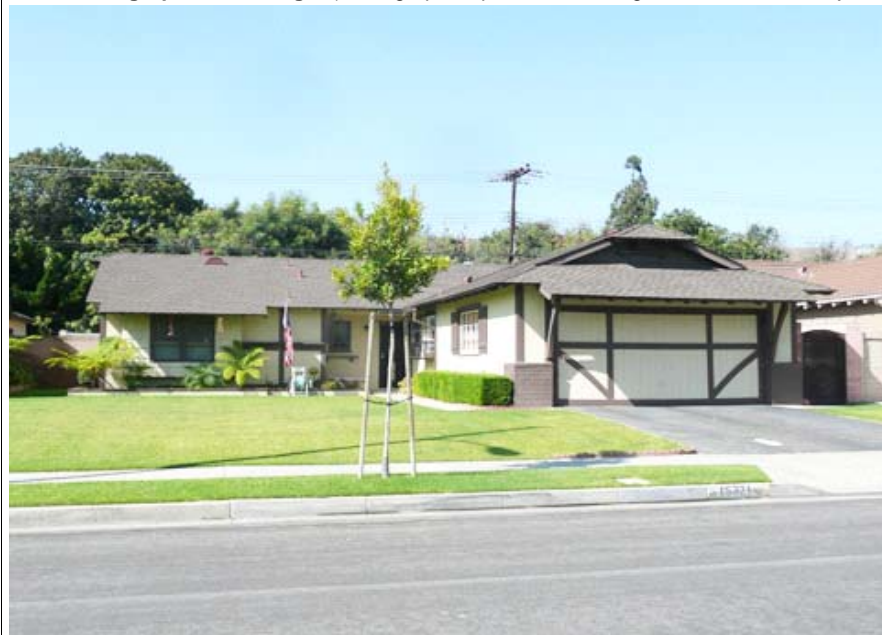
Facing west; 9/1/2010; Photo No.

* P3a. Description: (Describe resource and its major elements. Include design, materials, condition, alterations, size, setting, and boundaries.)
The one-story Ranch style building is 'L'-shaped in plan. The cross gable on hip roof, with clipped gable heads and exposed rafter tails, is clad in composition shingles. The exterior walls are clad in smooth textured stucco with corner boards and false timbering. The southern end of the south bay of the primary (east) façade is accented with a projecting bay clad in coursed shingles. The four-over-four wood sash windows appear to be original, and some windows have been replaced with aluminum sash units plus one greenhouse window. The window on the garage is accented with shutters, and the window in the central bay is accented with a flowerbox ledge. The primary entrance is recessed. An attached two-car garage projects from the northern end of the primary (east) façade, and is accented with brick veneer piers on the corners, a pent roof with triangulated knee brackets, and a flowerbox ledge in the gable. The building does not meet the NRHP and CRHR eligibility criteria for the reasons identified on the district record prepared for this subdivision; therefore the building does not contribute to a historic district and is not individually eligible for listing in the NRHP and the CRHR.

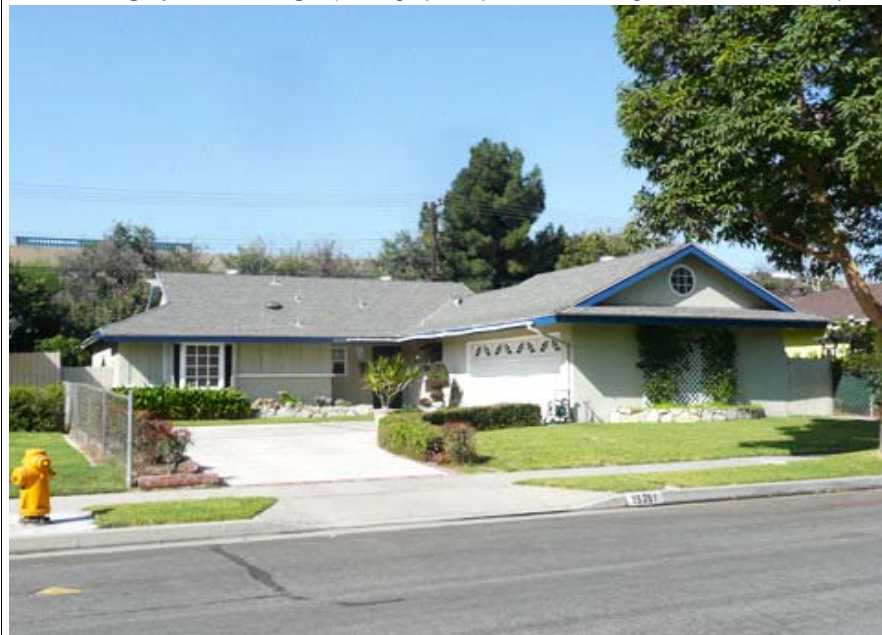
Facing west; 9/1/2010; Photo No.

* P3a. Description: (Describe resource and its major elements. Include design, materials, condition, alterations, size, setting, and boundaries.)
The one-story Ranch style building is 'L'-shaped in plan. The cross gable on hip roof, with boxed eaves, is clad in composition shingles. The south-facing gable is accented with a notched false beam. The vent in the east-facing gable has been replaced with a vinyl fixed-pane ox-eye window. The exterior walls are clad in smooth textured stucco. The southern bay is clad in smooth textured stucco to the water line and board and batten siding with a band board accenting the transition, which is accented with a canted bay with wood casement and fixed-pane windows. The remaining windows on the primary (east) façade have been replaced with vinyl sash units and a greenhouse window. The primary entrance is recessed. Landscaping includes stone planters. The building does not meet the NRHP and CRHR eligibility criteria for the reasons identified on the district record prepared for this subdivision; therefore the building does not contribute to a historic district and is not individually eligible for listing in the NRHP and the CRHR.

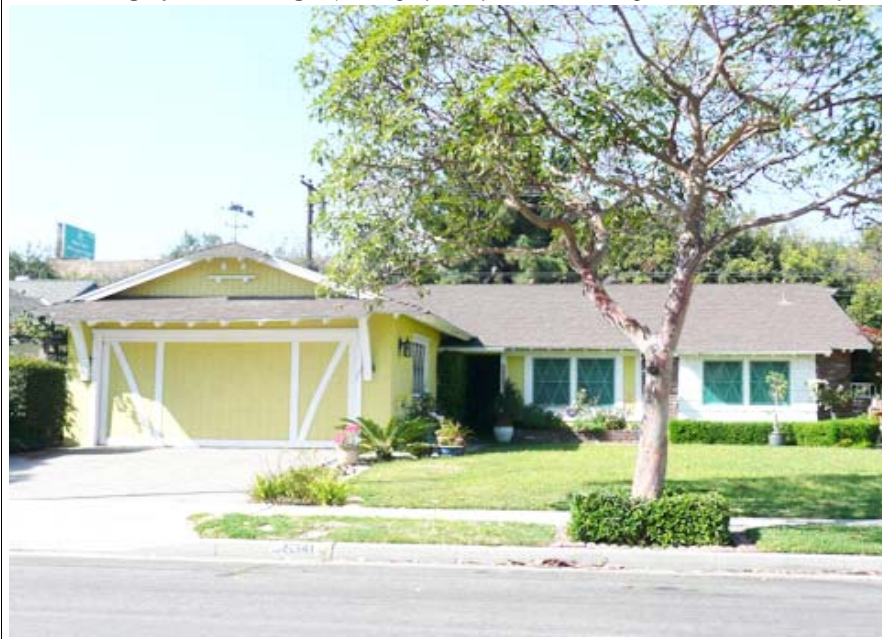
Facing west; 9/1/2010; Photo No.

* P3a. Description: (Describe resource and its major elements. Include design, materials, condition, alterations, size, setting, and boundaries.)
The one-story Ranch style building is 'L'-shaped in plan. The cross gabled roof, with exposed rafter tails and clipped gable heads, is clad in composition shingles. The exterior walls are clad in smooth textured stucco, with some false timbering, and brick veneer. The northern end of the primary (eastern) façade is accented with a projecting bay clad in coursed shingles. The diamond-paned sash and fixed-pane windows appear to be original. The primary entrance is at grade and is recessed. An attached two-car garage projects from the southern end of the primary (eastern) façade. The eastern façade of the garage is accented with a pent roof with triangulated knee brackets, vertical wood siding in the gable, a dovetail, and a weathervane. The building does not meet the NRHP and CRHR eligibility criteria for the reasons identified on the district record prepared for this subdivision; therefore the building does not contribute to a historic district and is not individually eligible for listing in the NRHP and the CRHR.

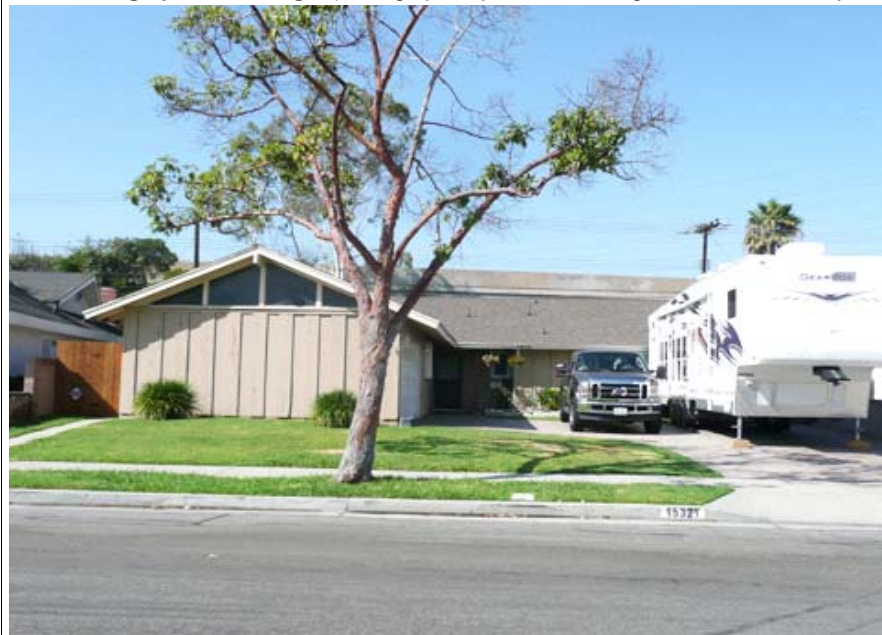
Facing west; 9/1/2010; Photo No.

* P3a. Description: (Describe resource and its major elements. Include design, materials, condition, alterations, size, setting, and boundaries.)
The one-story Ranch style building is 'L'-shaped in plan. The cross gabled roof is clad in composition shingles. The northeasterly gable is accented with fixed-pane with fritted glass transom windows and false beams. The exterior walls are clad in board and batten siding. The northerly bay is accented with a canted bay with vinyl sash windows. The other windows have been replaced with vinyl sash units. The primary entrance is recessed and is at grade. An attached two-car garage projects from the southern end of the primary (eastern) façade, and the window on the north face of the garage is accented with an exaggerated wood surround. The building does not meet the NRHP and CRHR eligibility criteria for the reasons identified on the district record prepared for this subdivision; therefore the building does not contribute to a historic district and is not individually eligible for listing in the NRHP and the CRHR.

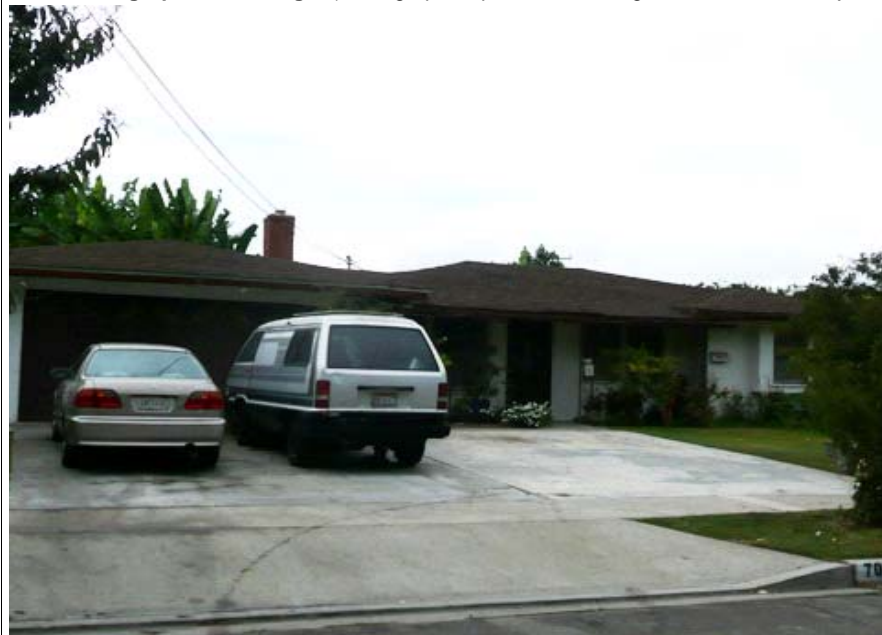
Facing north; 10/5/2010; Photo No.

* P3a. Description: (Describe resource and its major elements. Include design, materials, condition, alterations, size, setting, and boundaries.)
The one-story Ranch style building is rectangular in plan. The cross hipped roof, with boxed eaves, is clad in composition shingles. A brick chimney is located on the north face of the roof. The exterior walls are clad in smooth textured stucco. The four-over-four wood sash windows appear to be original. The primary entrance is at grade, and is recessed. The roof overhangs to shelter the primary entrance porch, and is supported with decorative metal columns.

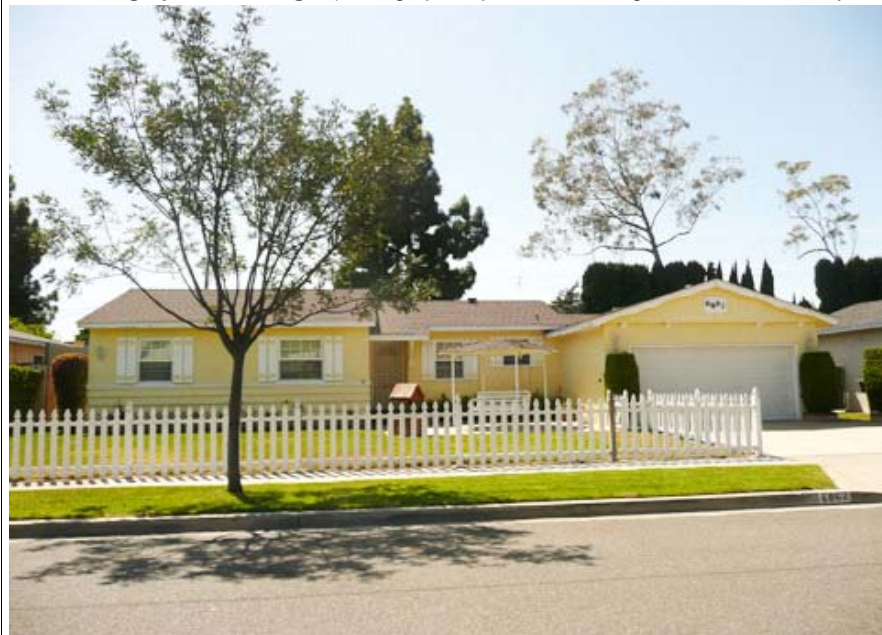
* P3a. Description: (Describe resource and its major elements. Include design, materials, condition, alterations, size, setting, and boundaries.)
Of the 31 parcels of the tract located within the APE, only three possessed sufficient integrity to warrant further investigation, which resulted in the subdivision retaining 10 percent integrity. None of the three buildings intensively surveyed for this project appear to possess sufficient architectural quality for the reasons identified in the district record to be considered eligible for listing in the NRHP or the CRHR either individually or as a historic district.

View of a common Ranch style building in this district.

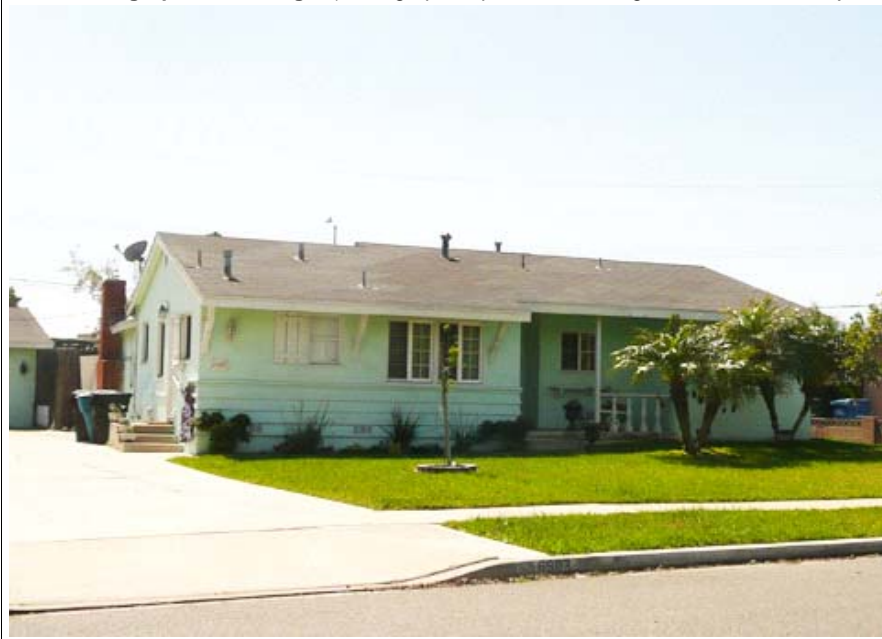
Facing southwest; 4/1/2010; Photo No.

* P3a. Description: (Describe resource and its major elements. Include design, materials, condition, alterations, size, setting, and boundaries.)
The one-story Ranch style building is generally rectangular in plan. The side gabled roof, with boxed eaves, is clad in composition shingles. The eaves on the primary (northeast) façade as accented with brackets. The exterior walls are clad in smooth textured stucco with horizontal wood siding to the water line on the southerly end of the primary (northeast) façade. The windows were replaced with vinyl sliding and sash units at an unknown date, and one window is partially accented with a wood shutter. The primary entrance is raised, recessed, and accessed via a cast concrete porch. A wood railing with a turned balustrade partially encloses the entry porch. The roof overhangs to shelter the entryway, and is supported by a square wood post. A flowerbox ledge accents the window located in the primary entry porch bay. A secondary entrance is located on the southeastern façade of the building, and is accessed via a simple cast concrete porch. A detached garage is located in the rear of the parcel. The building does not meet the NRHP and CRHR eligibility criteria for the reasons identified on the district record prepared for this subdivision; therefore the building does not contribute to a historic district and is not individually eligible for listing in the NRHP and the CRHR.

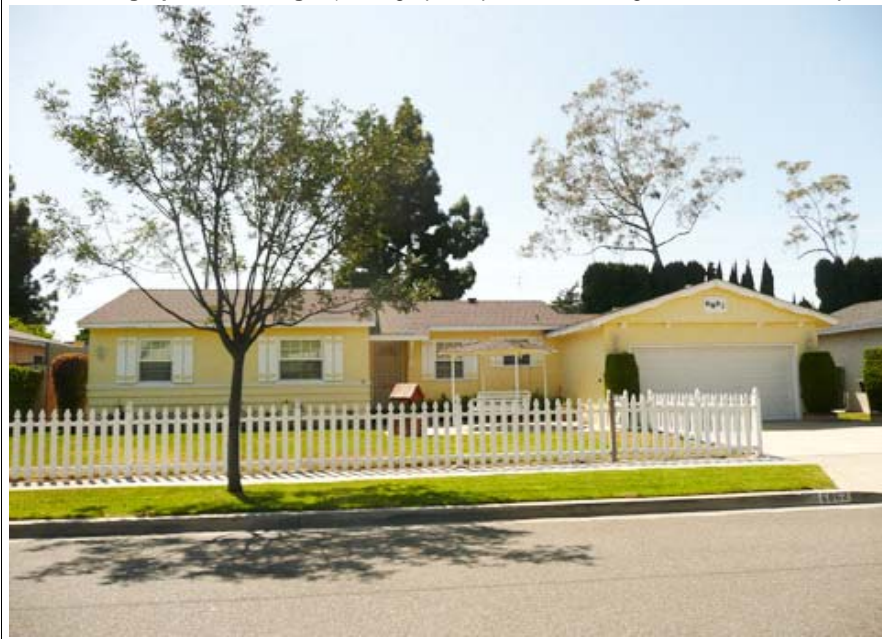
Facing southwest; 4/1/2010; Photo No.
P1040153.jpg

* P3a. Description: (Describe resource and its major elements. Include design, materials, condition, alterations, size, setting, and boundaries.)
The one-story Ranch style building is 'L'-shaped in plan. The cross gabled roof, with boxed eaves, is clad in composition shingles. The front-facing gable is accented with scalloped barge board, vertical wood siding, and corbels. The exterior walls are clad in smooth textured stucco with horizontal wood siding to the water line on the southerly end of the primary (northeast) façade. The windows were replaced with vinyl sash units at an unknown date, and the windows are accented with decorative shutters. The primary entrance is raised and accessed via a small covered porch. The roof overhangs to shelter the entry porch, and is supported by a decorative bracket. The building does not meet the NRHP and CRHR eligibility criteria for the reasons identified on the district record prepared for this subdivision; therefore the building does not contribute to a historic district and is not individually eligible for listing in the NRHP and the CRHR.

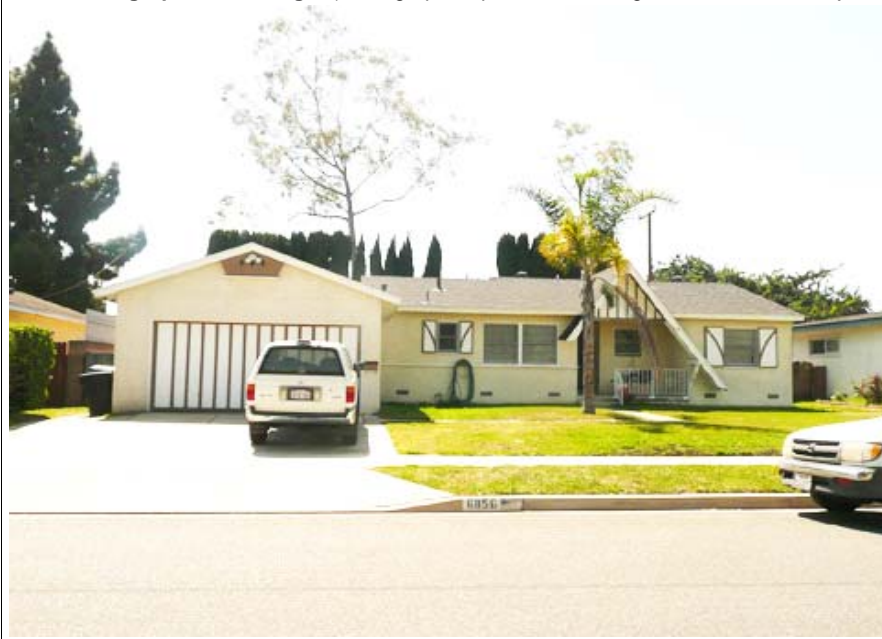
Facing southwest; 4/1/2010; Photo No.
P1040154.jpg

* P3a. Description: (Describe resource and its major elements. Include design, materials, condition, alterations, size, setting, and boundaries.)
The one-story Chalet- Ranch style building is 'L'-shaped in plan. The crossed gabled roof is clad in composition shingles. The northerly front-facing gable is asymmetrical, and is accented with scalloped barge board and false timbering. The southerly front-facing gable is accented with a dovecote. The exterior walls are clad in smooth textured stucco with a band board at the water line to accent the central bay of the primary (easterly) façade. The six-over-six, one-over-one, and diamond-pane wood sash windows appear to be original and some are accented with shutters. The primary entrance is raised, recessed, and accessed via a cast concrete porch with metal railing. An attached two-car garage projects from the southerly end of the primary (northeast) façade, and is characterized by a wood pivot door with false timbering. The building does not meet the NRHP and CRHR eligibility criteria for the reasons identified on the district record prepared for this subdivision; therefore the building does not contribute to a historic district and is not individually eligible for listing in the NRHP and the CRHR.

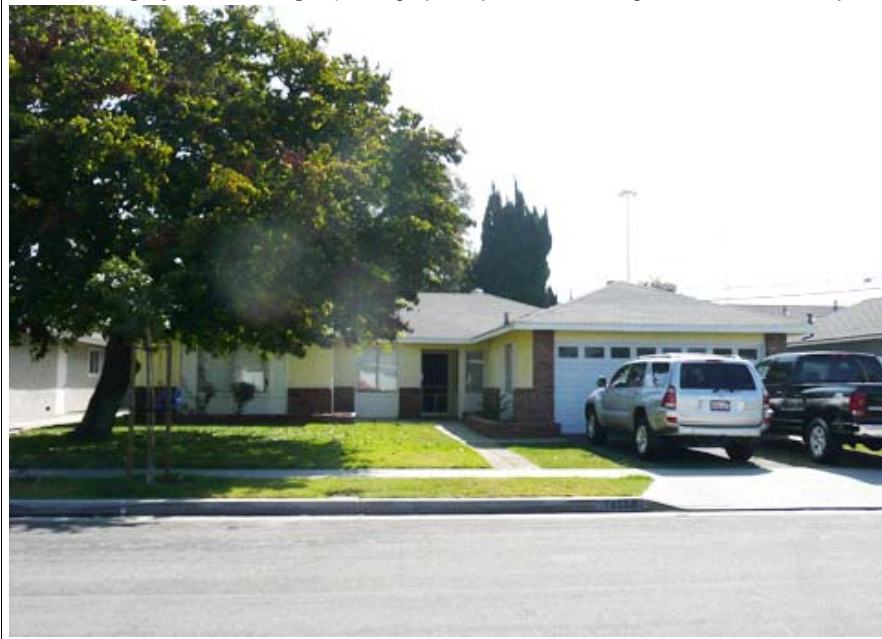
* P3a. Description: (Describe resource and its major elements. Include design, materials, condition, alterations, size, setting, and boundaries.)
Of the 8 parcels of Tract 3995 that are located within the APE, three contained buildings with sufficient integrity to warrant further investigation, which resulted in the subdivision retaining 38 percent integrity. None of the three buildings appear to possess sufficient architectural quality for the reasons identified in the district record to be considered eligible for listing in the NRHP or the CRHR as individual historic resources or as a historic district.

View of a common Ranch style building found in this district.

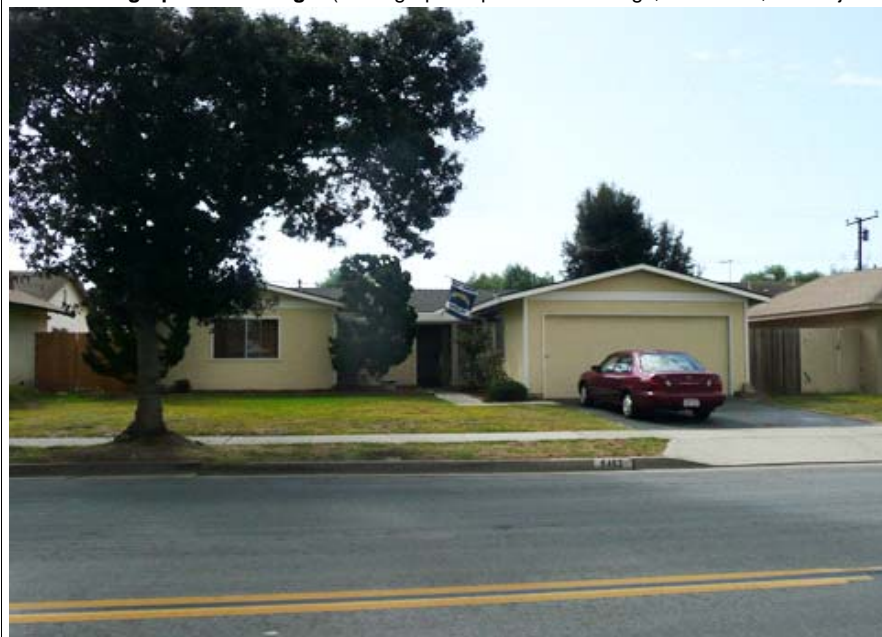
Facing south; 10/7/2010; Photo No.

* P3a. Description: (Describe resource and its major elements. Include design, materials, condition, alterations, size, setting, and boundaries.)
The one-story Ranch style building is 'U'-shaped in plan. The cross gable roof, with boxed eaves, is clad in composition shingles. The front-facing gables are accented with band boards. The exterior walls are clad in smooth textured stucco. The windows appear to have been replaced with modern aluminum or vinyl sliding units. The primary entrance is raised, and is accessed via a cast concrete porch. The building does not meet the NRHP and CRHR eligibility criteria for the reasons identified on the district record prepared for this subdivision; therefore the building does not contribute to a historic district and is not individually eligible for listing in the NRHP and the CRHR.

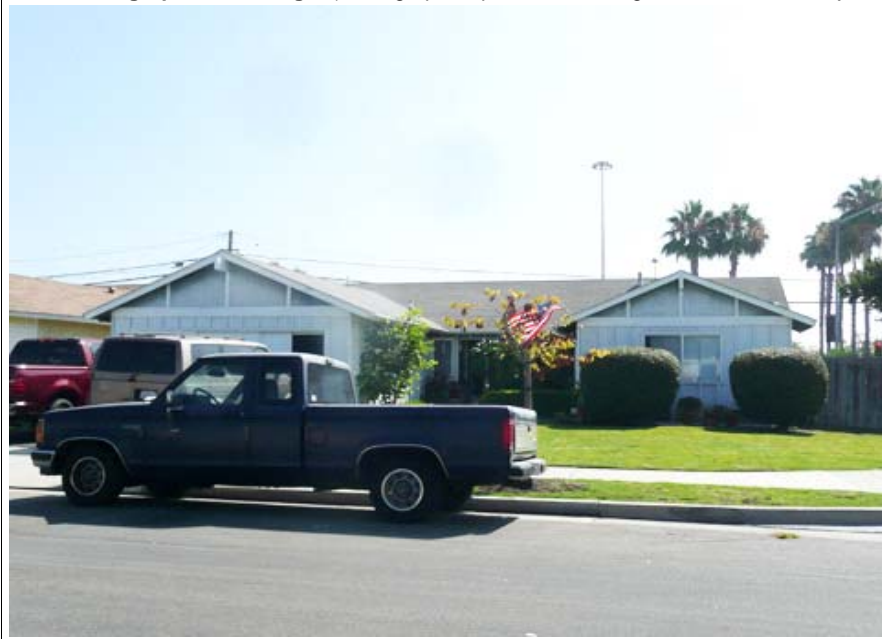
Facing east; 9/1/2010; Photo No.

* P3a. Description: (Describe resource and its major elements. Include design, materials, condition, alterations, size, setting, and boundaries.)
The one-story Ranch style building is 'L'-shaped in plan. The cross gabled roof, with boxed eaves, is clad in composition shingles. The front facing gables are accented with false beams and batten. The exterior walls are clad in textured stucco and batten. Band boards visually separate the gables from the exterior walls. The aluminum sliding windows appear to be original. The primary entrance is recessed. The building does not meet the NRHP and CRHR eligibility criteria for the reasons identified on the district record prepared for this subdivision; therefore the building does not contribute to a historic district and is not individually eligible for listing in the NRHP and the CRHR.

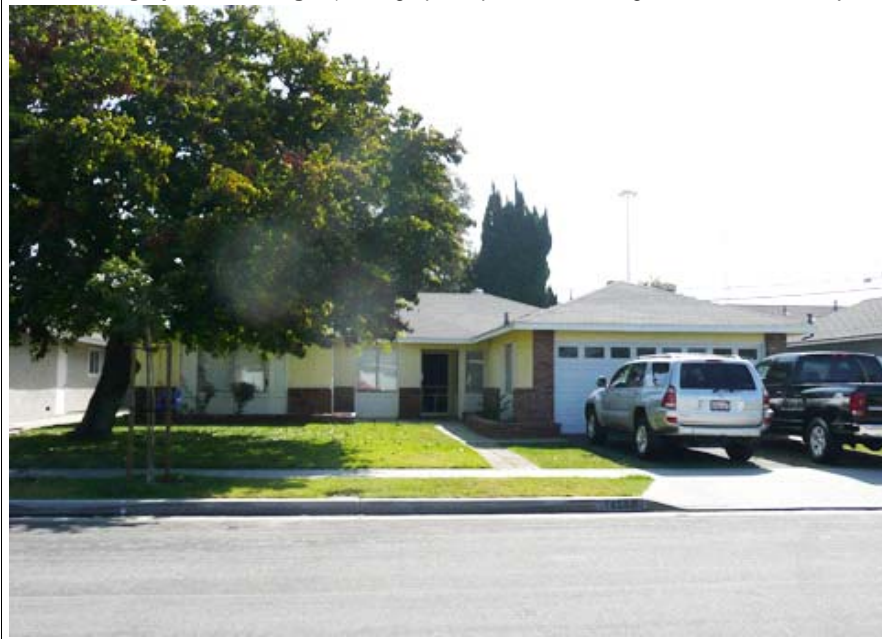
Facing east; 9/1/2010; Photo No.

* P3a. Description: (Describe resource and its major elements. Include design, materials, condition, alterations, size, setting, and boundaries.)
The one-story Ranch style building is 'L'-shaped in plan. The cross pyramidal and side gable roof, with boxed eaves, is clad in composition shingles. The exterior walls are clad in smooth textured stucco, brick veneer, and vertical wood siding. The aluminum sliding windows appear to be original, and are accented with shutters and louvered spandrel panels. The primary entrance is recessed, and at grade. The building does not meet the NRHP and CRHR eligibility criteria for the reasons identified on the district record prepared for this subdivision; therefore the building does not contribute to a historic district and is not individually eligible for listing in the NRHP and the CRHR.

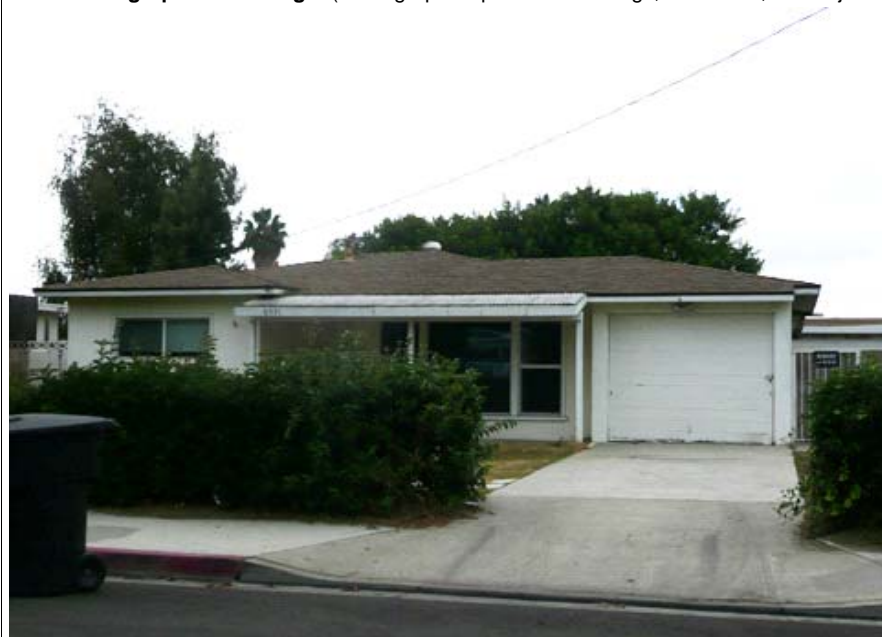
Facing north; 10/5/2010; Photo No.

* P3a. Description: (Describe resource and its major elements. Include design, materials, condition, alterations, size, setting, and boundaries.)
The one-story Ranch style building is generally rectangular in plan. The cross hipped roof, with boxed eaves, is clad in composition shingles. The exterior walls are clad in smooth textured stucco. The windows have been replaced with vinyl sash and fixed-pane units. The primary entrance is recessed and is at grade. A pent roof, with corrugated fiberglass cladding, spans the recessed entry bay, and is supported by square wood posts.

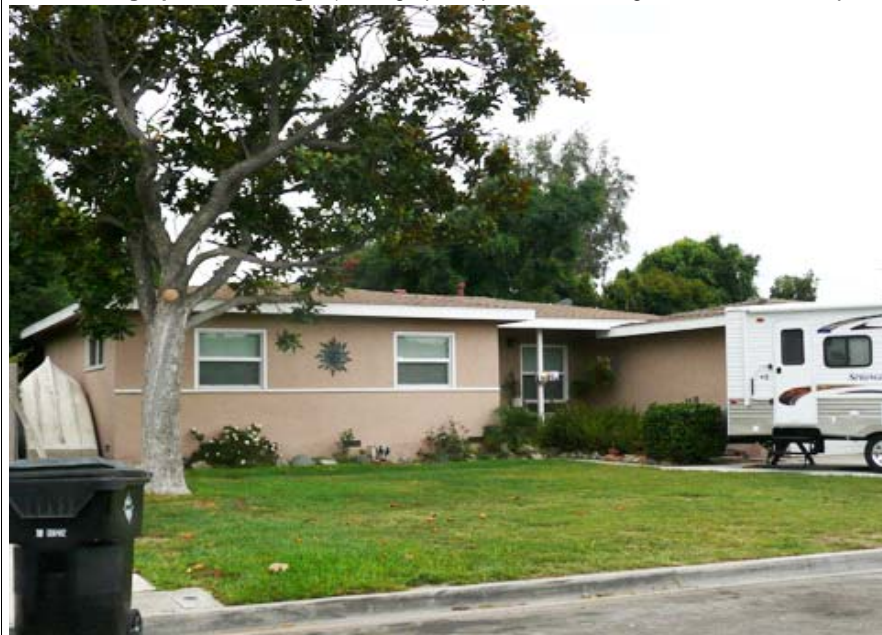
* P3a. Description: (Describe resource and its major elements. Include design, materials, condition, alterations, size, setting, and boundaries.)
Of the 10 parcels of the tract located within the APE, only five possessed sufficient integrity to warrant further investigation, which resulted in the subdivision retaining 50 percent integrity. None of the four buildings intensively surveyed for this project appear to possess sufficient architectural quality for the reasons identified in the district record to be considered eligible for listing in the NRHP or the CRHR either individually or as a historic district.

View of a typical Ranch style building in this district.

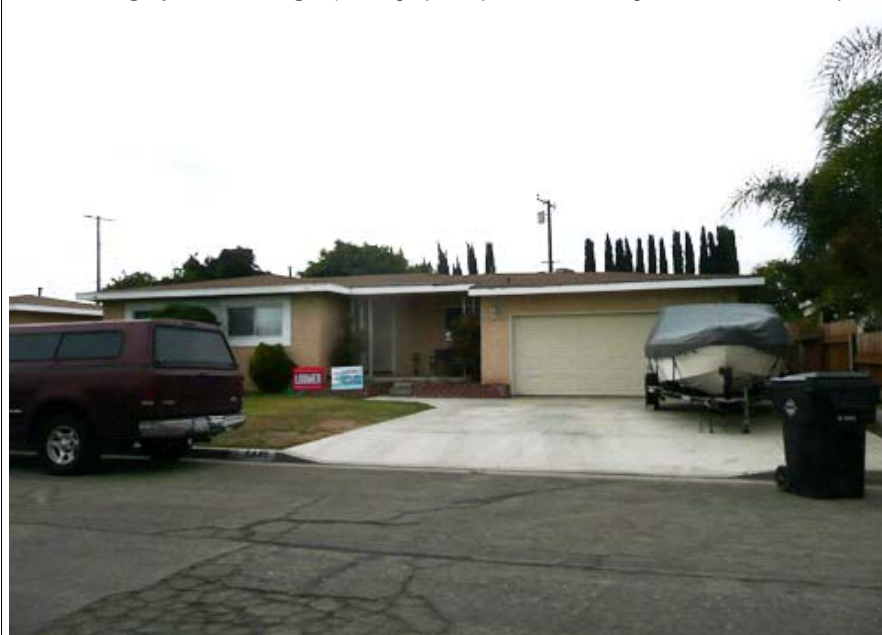
Facing north; 10/5/2010; Photo No.

* P3a. Description: (Describe resource and its major elements. Include design, materials, condition, alterations, size, setting, and boundaries.)
The one-story Ranch style building is rectangular in plan. The cross hipped roof, with boxed eaves, is clad in composition shingles. The exterior walls are clad in smooth textured stucco. The windows have been replaced with vinyl sliding units, and the windows located in the western bay of the primary (southern) façade are accented with an exaggerated wood surround. The primary entrance is raised, recessed, and accessed via a cast concrete porch. The roof overhangs to shelter the primary entry porch, and is supported by square wood posts. Landscaping includes brick planters. The building does not meet the NRHP and CRHR eligibility criteria for the reasons identified on the district record prepared for this subdivision; therefore the building does not contribute to a historic district and is not individually eligible for listing in the NRHP and the CRHR.

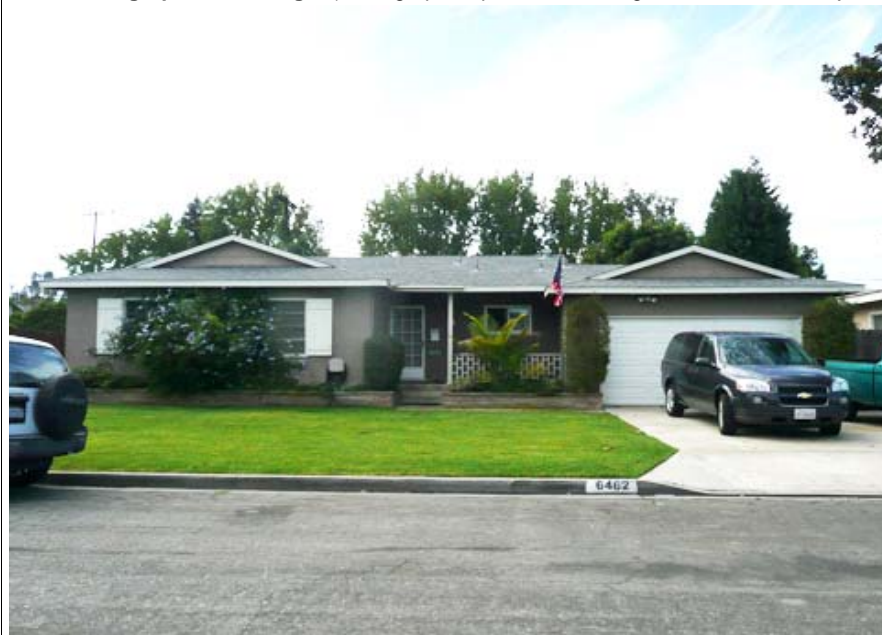
Facing south; 9/29/2010; Photo No.

* P3a. Description: (Describe resource and its major elements. Include design, materials, condition, alterations, size, setting, and boundaries.)
The one-story Ranch style building is rectangular in plan. The cross gable on hip roof, with boxed and flared eaves, is clad in composition shingles. The front-facing gables are accented with horizontal wood siding. The exterior walls are clad in smooth textured stucco. The one-over-one wood sash windows appear to be original and are accented with shutters. At least one window has been replaced with a vinyl sliding unit. The primary entrance is raised, and accessed via a cast concrete porch, which is partially enclosed with a geometric-patterned railing. The overhanging roof is supported by a square column. Landscaping includes Roman brick planters. The building does not meet the NRHP and CRHR eligibility criteria for the reasons identified on the district record prepared for this subdivision; therefore the building does not contribute to a historic district and is not individually eligible for listing in the NRHP and the CRHR.

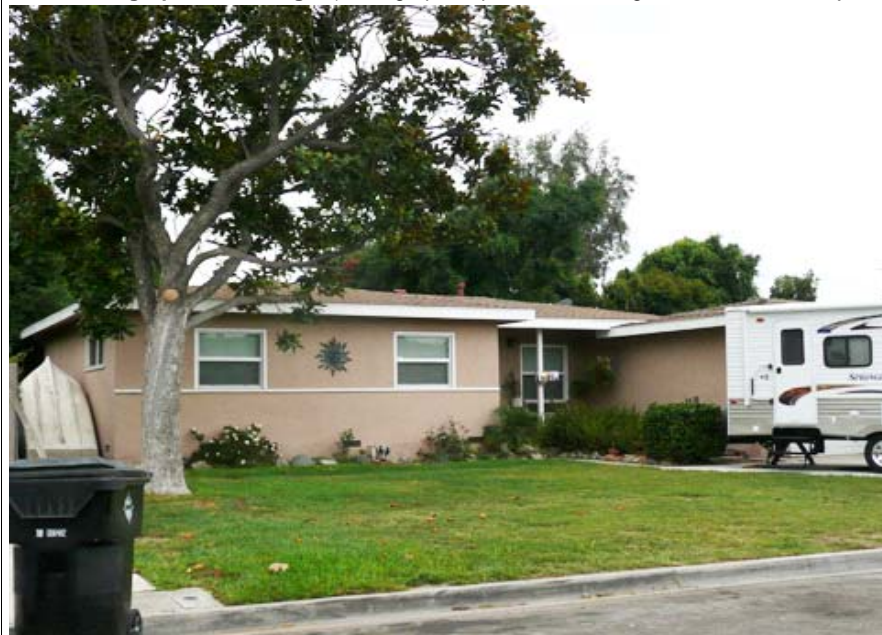
Facing south; 10/5/2010; Photo No.

* P3a. Description: (Describe resource and its major elements. Include design, materials, condition, alterations, size, setting, and boundaries.)
The one-story Ranch style building is 'L'-shaped in plan. The cross hipped roof, with boxed eaves, is clad in composition shingles. The exterior walls are clad in smooth textured stucco, and the eastern bay of the primary (northern) façade is accented with a band board at the water line. The windows have been replaced with vinyl sash units. The primary entrance is recessed, and accessed via a cast concrete covered porch. The roof overhangs to shelter the primary entryway, and is supported by a square wood post. The building does not meet the NRHP and CRHR eligibility criteria for the reasons identified on the district record prepared for this subdivision; therefore the building does not contribute to a historic district and is not individually eligible for listing in the NRHP and the CRHR.

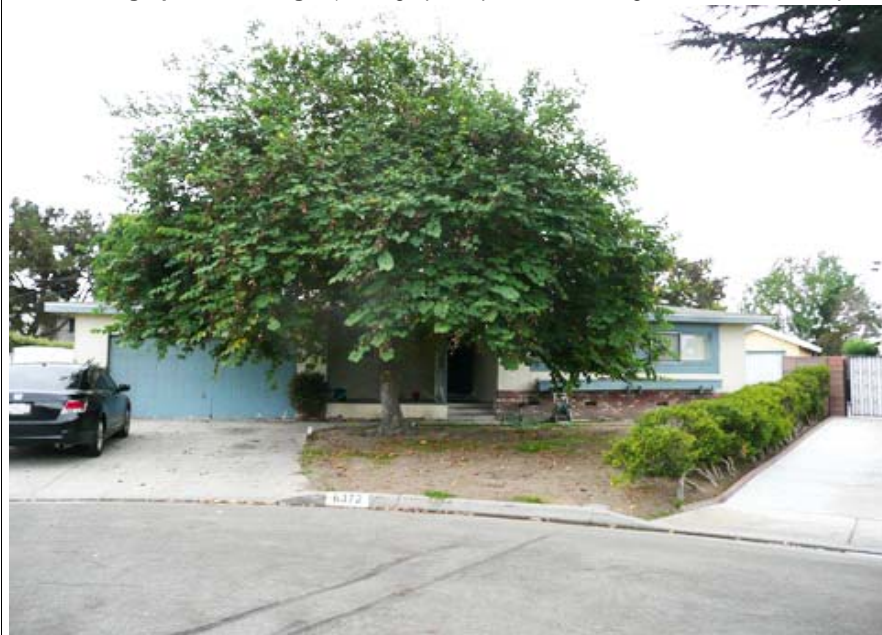
Facing southwest; 10/5/2010; Photo No.
P1040829.jpg

* P3a. Description: (Describe resource and its major elements. Include design, materials, condition, alterations, size, setting, and boundaries.)
The one-story Ranch style building is rectangular in plan. The cross hipped roof is clad in composition shingles. The exterior walls are clad in smooth textured stucco, and the northerly bay of the primary (northeast) façade is accented with brick veneer to the water line. The aluminum sliding windows appear to be original, and the northerly windows on the primary façade are accented with an exaggerated wood surround. The primary entrance is raised, recessed, and accessed via a covered cast concrete porch. The roof overhangs to shelter the entry porch, and is supported by a square wood post. The porch is partially enclosed with a decorative wood railing, which is in poor condition. The building does not meet the NRHP and CRHR eligibility criteria for the reasons identified on the district record prepared for this subdivision; therefore the building does not contribute to a historic district and is not individually eligible for listing in the NRHP and the CRHR.

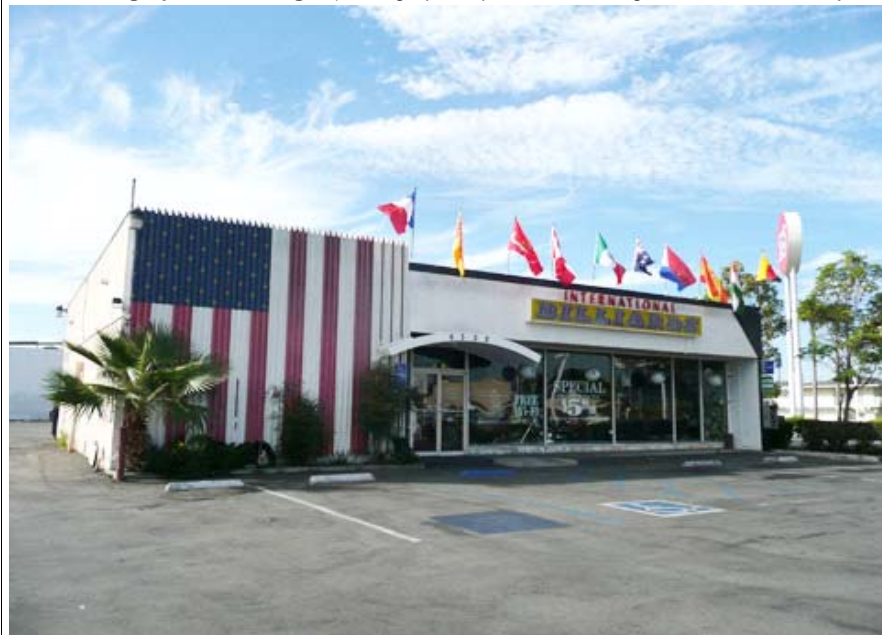
Facing south, 10/7/2010; Photo No.

* P3a. Description: (Describe resource and its major elements. Include design, materials, condition, alterations, size, setting, and boundaries.)
The one-story building is square in plan. The flat roof is clad in composition roll. The exterior walls are clad in smooth textured stucco. A decorative wood grill accents the eastern end of the primary (northern) façade and is painted to resemble the American flag with star tie-back accents. The aluminum storefront windows and primary entry door appear to be original and are recessed. An arched awning shelters the primary entryway. The recessed bay of the primary (northern) façade is accenting with hanging ball lights with decorative numbers to resemble billiard balls.
